Barnhill SHD

Stage 1 Road Safety Audit

P22-091-RSA-PD-RP-001

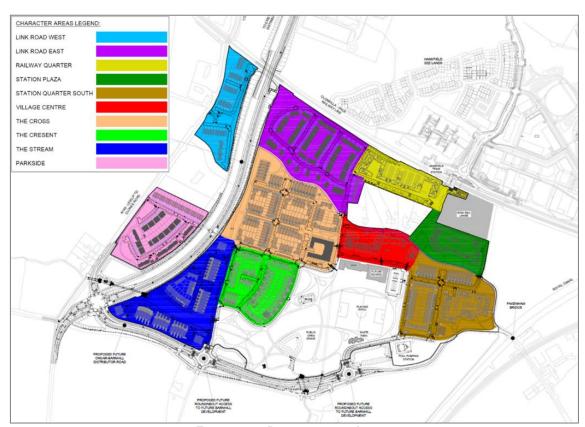
FIGURE 2-3: DEVELOPMENT AREAS

The proposed development is split into small areas as follows: -

- Link Road West
- Link Road East
- Railway Quarter
- Station Plaza
- Station Quarter South

- Village Centre Residential
- Barnhill Cross
- Barnhill Crescent
- Barnhill Stream
- Parkside

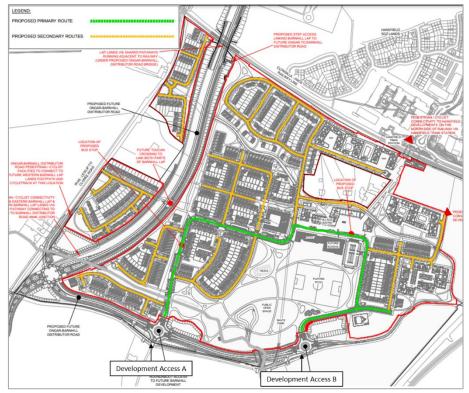
FIGURE 2-4: PROPOSED ROAD NETWORK

The proposed development would include four vehicular accesses, two from the Clonee Road (R149) and two from the proposed Ongar-Barnhill Distributor Road. The road network would comprise of a single primary route (spine road) that runs from two accesses along the proposed Ongar-Barnhill Distributor Road, and multiple secondary routes, that link to the spine road, and which would provide access to the residential units.

The spine road would be a single carriageway and include segregated footpath and cycle track along both sides. The secondary routes would consist of shared carriageways (vehicle/ cyclist shared carriageway) and footpaths.

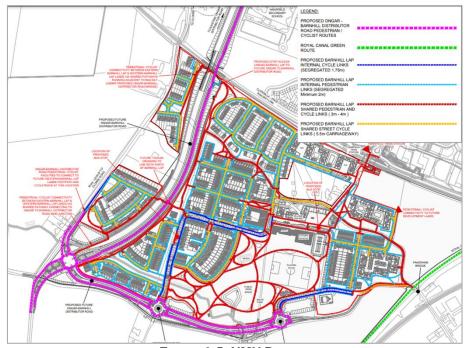
FIGURE 2-5: NMU ROUTES

A network to accommodate non-motorised road users (e.g. pedestrians and cyclists) would extend through the entire development, along all roads and through the proposed parks. The footpaths would have a minimum width of 2.0 metres and the cycle tracks would be 1.75 metres wide. The areas where pedestrians and cyclists would be accommodated within a shared space would be 3m to 4m wide. Two pedestrian/cycle links would be provided across the proposed Ongar-Barnhill Road to provide connection between the residential properties on either side of this road, one adjacent to the railway in the northern section of the site and one via a signalised crossing of the Distributor Road between Parkside and the eastern portion of the site.

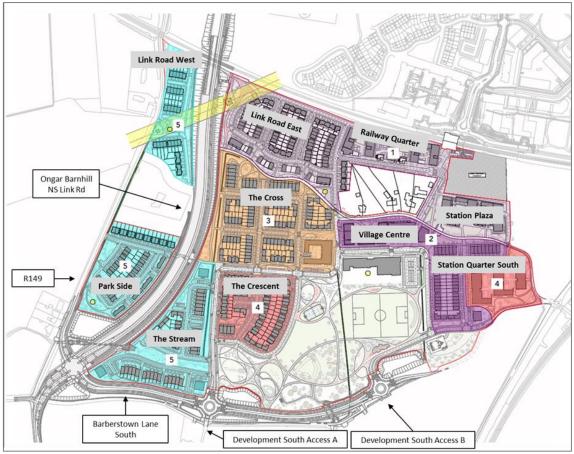
FIGURE 2-6: CONSTRUCTION PHASES AREAS

The construction of the proposed development would be undertaken in five phases, as shown on Figure 2-6 and Table 2.2.

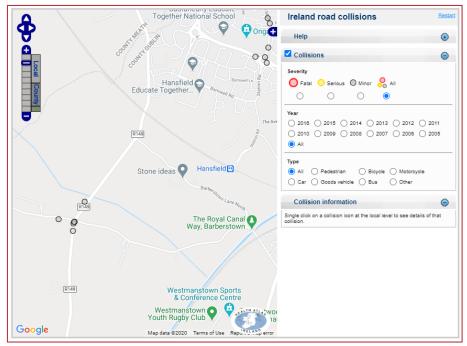
FIGURE 2-8: COLLISIONS RECORDED ON THE ROAD SAFETY AUTHORITY'S COLLISION DATABASE IN THE VICINITY OF THE PROPOSED DEVELOPMENT (SOURCE: WWW.RSA.IE)

The Road Safety Authority website (www.rsa.ie) was consulted to identify historical collisions in the vicinity of the proposed Scheme. The website includes summary information on recorded collision occurrence for the period 2005 to 2016. 6 Minor Injury collisions were recorded on the R149 in the vicinity of its junction with Barberstown Lane South.

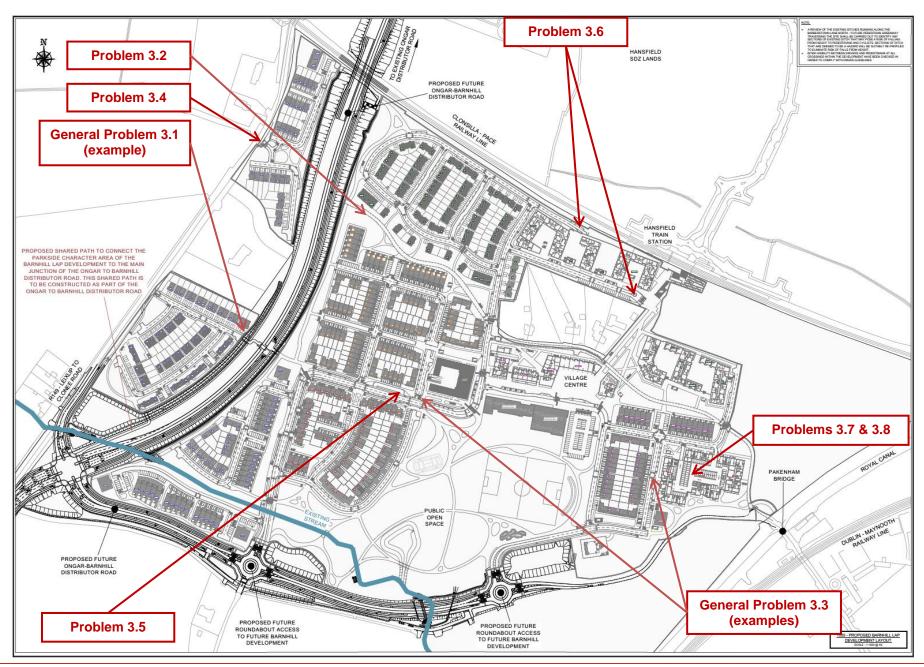
Appendix D – Problem Locations

Where problems are relevant to specific locations these are shown on drawing extracts within the main body of the report and their locations are shown in Appendix D. Where problems are general to the proposals sample drawing extracts are within the main body of the report where considered necessary.
